REMOVAL ACTION REPORT

Anderson-Calhoun Mine/Mill Site Leadpoint, Washington

Contract No. 68-SO-1-03
TDD 02-10-0006

March 19, 2003

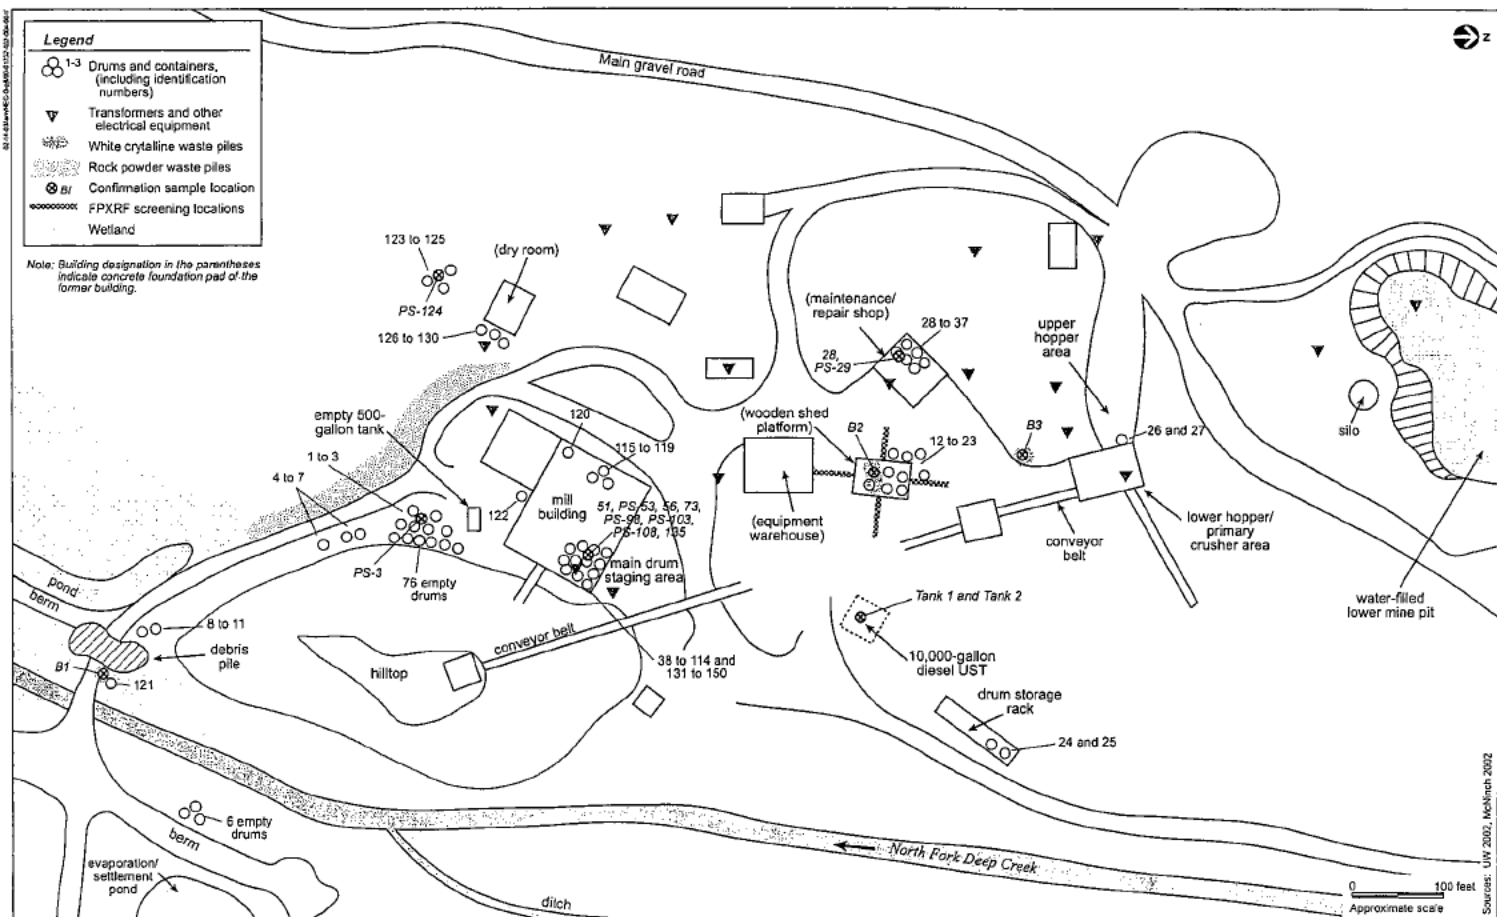
The following observations and hazard categorization results were collected from drums and containers located across the mine/mill site (Figure 5). Decision Area 1 was further segregated based on contaminants of concern and physical setting.

Figure 5. Drums, containers, and confirmation sample locations, Anderson-Calhoun Mine/Mill site in Leadpoint, Washington.
